Edge Storms: A Case Study

Wilfrid A. Nixon¹ and Bret Hodne²

Keywords: winter storm case study; winter highway maintenance; pavement temperature

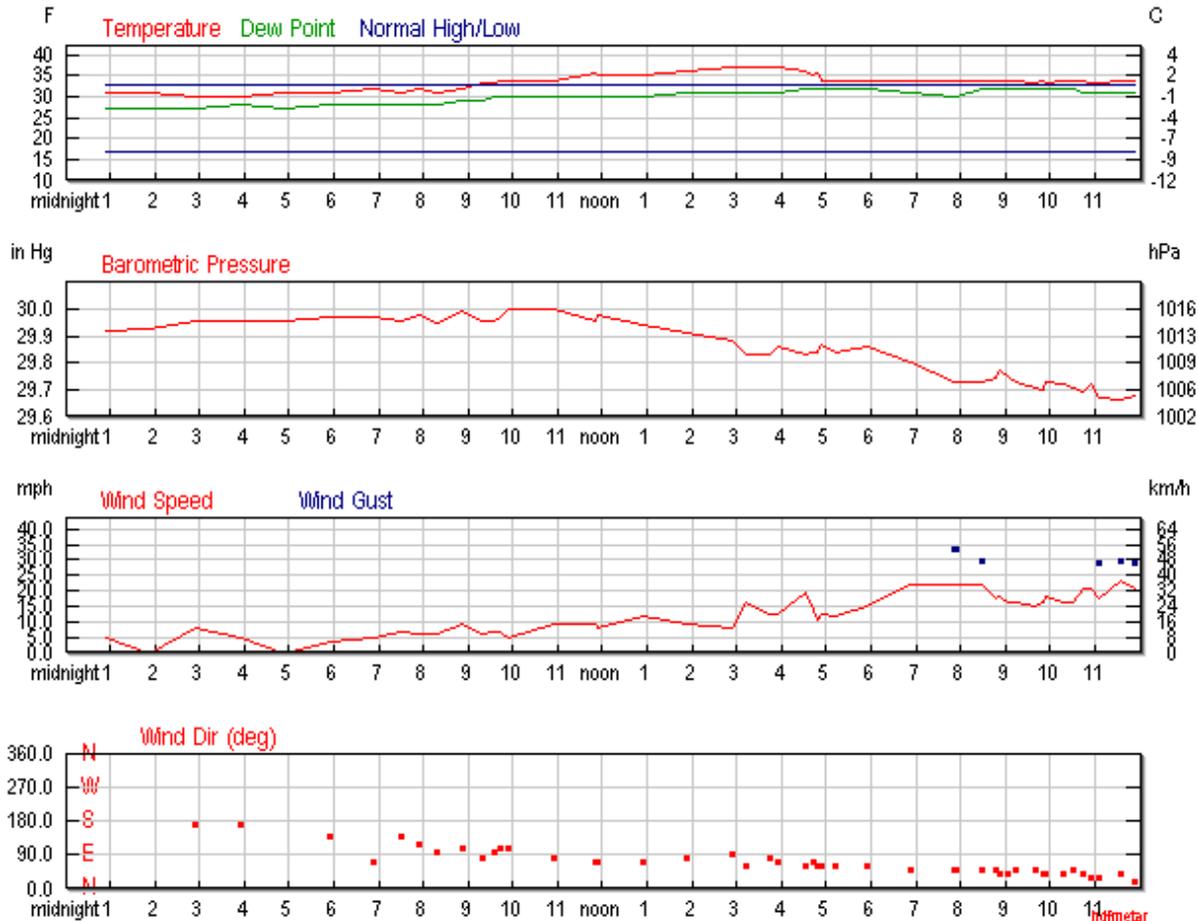
Figure 2: Temperature, Pressure, and Wind Data for 12/19/2012 [2]

The storm lasted from the afternoon of December 19, 2012 through the evening of December 20, 2012. While temperatures were in general close to freezing at the start of the storm, they began to fall on the second day. Wind speeds were high throughout the storm. Figure 2 shows the temperatures, barometric pressure and wind data from December 19 and figure 3 shows the same data for December 20 [2]. Figure 4 shows the weather map from NOAA for December 20, 2012 [3].

Snow started falling at 4:00pm 12/19/2012 and continued to fall until 10:00pm 12/20/2012 (all times, including in Figures 2 and 3 are local time). A total of 12.4 inches (31.5 cm) of snow fell in this time, with 5.6 inches (14.2 cm) on 12/19/2012 and 6.8 inches (17.3 cm) on 12/20/2012. The snow was very wet, and was interspersed with periods of sleet on 12/19. Wind speeds began at about 14 mph sustained (about 22 kph) at the start of the storm and rose as high as 35 mph sustained (about 56 kph) in mid-afternoon on 12/20/2012. Wind gusts were as high as 54 mph (86 kph) that afternoon. The air temperature was slightly above freezing from the start of the storm until about 3 a.m. on 12/20/2012. Thereafter it dropped steadily until, at the end of the snow event, the air temperature was about -9°C .

Pavement temperatures started at about $+0.5^{\circ}\text{C}$ and continued to hold relatively steady in the range of 0° to -0.5°C during most of the storm. However, at about 3 p.m. on 12/20/2012 the pavement temperature began to fall steadily, reaching -10°C on 12/22/2012 at about 7 a.m.

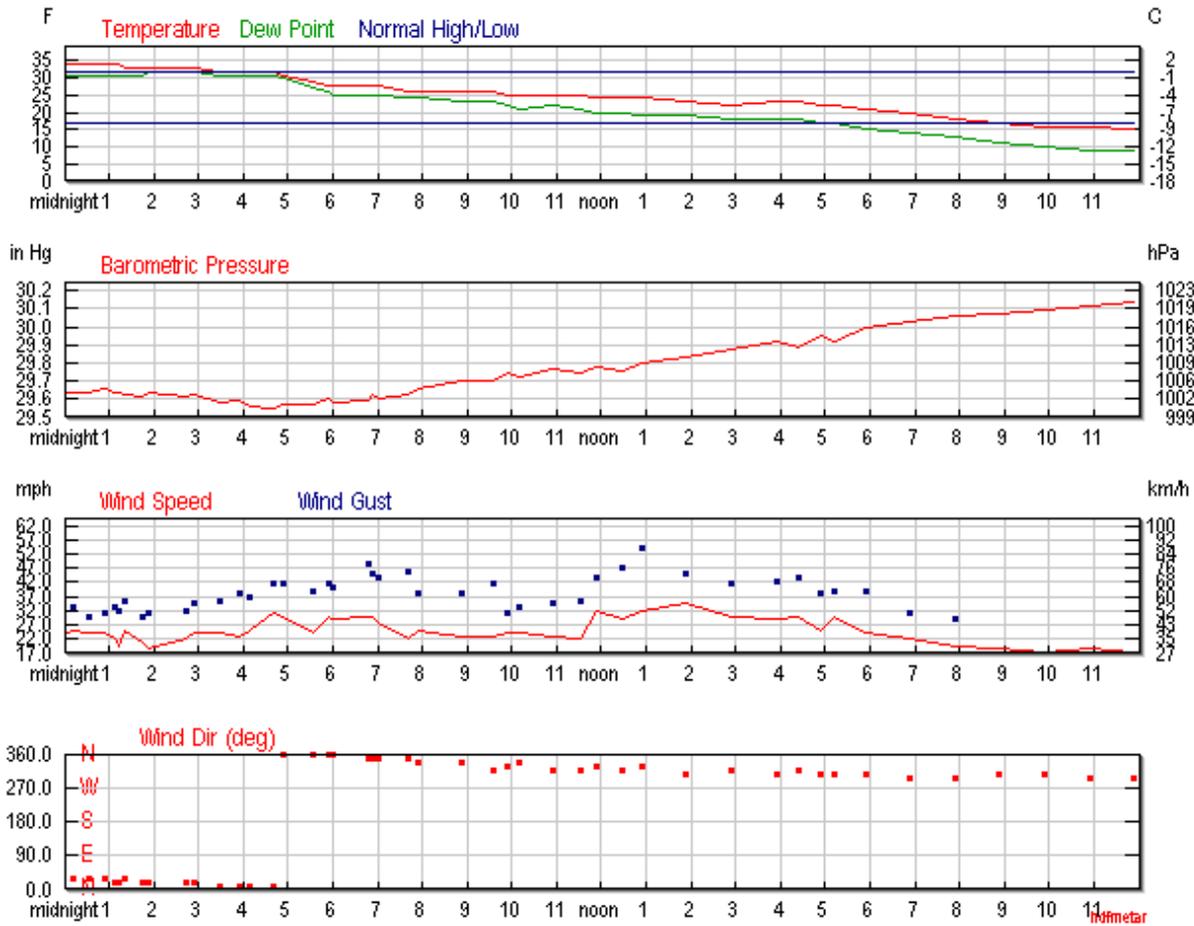
Figure 3: Temperature, Pressure, and Wind Data for 12/20/2012 [2]

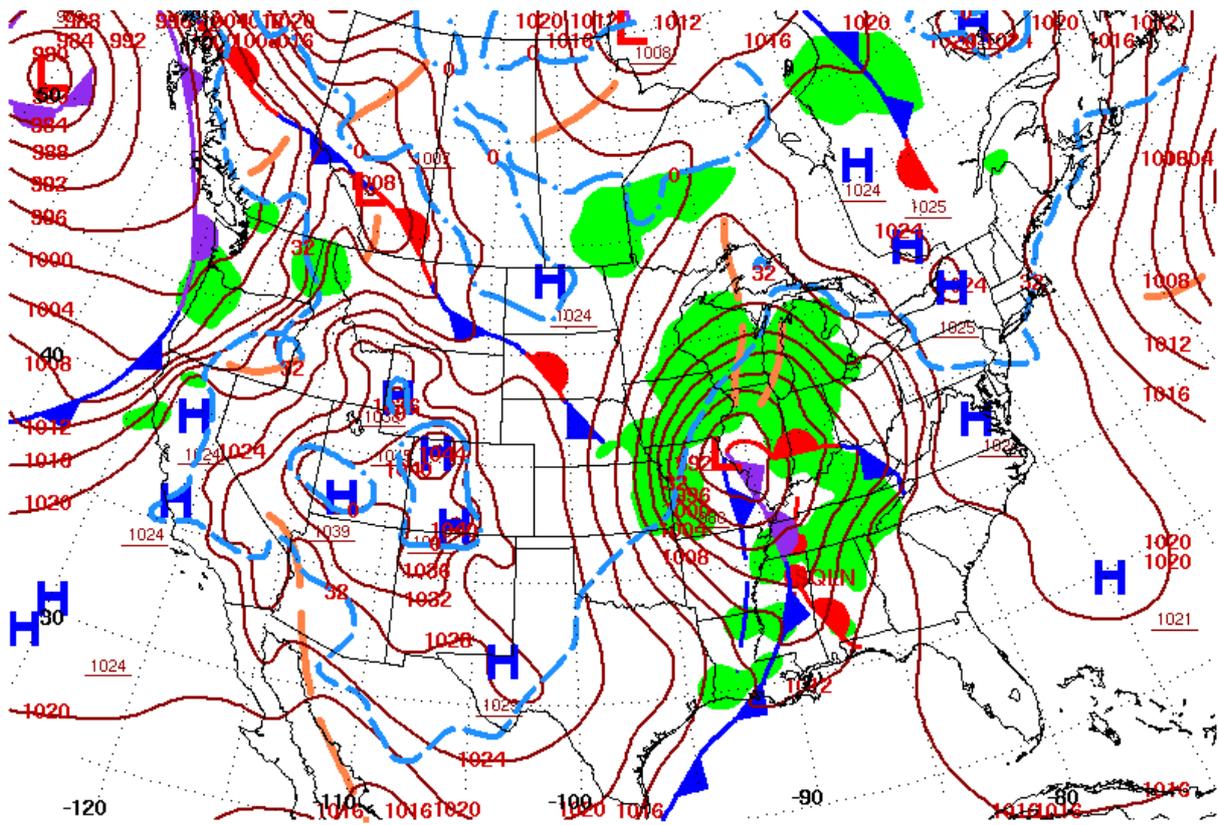
Surface Weather Map at 7:00 A.M. E.S.T.

Figure 4: Surface Weather Map for US December 20, 2012, from NOAA [3].

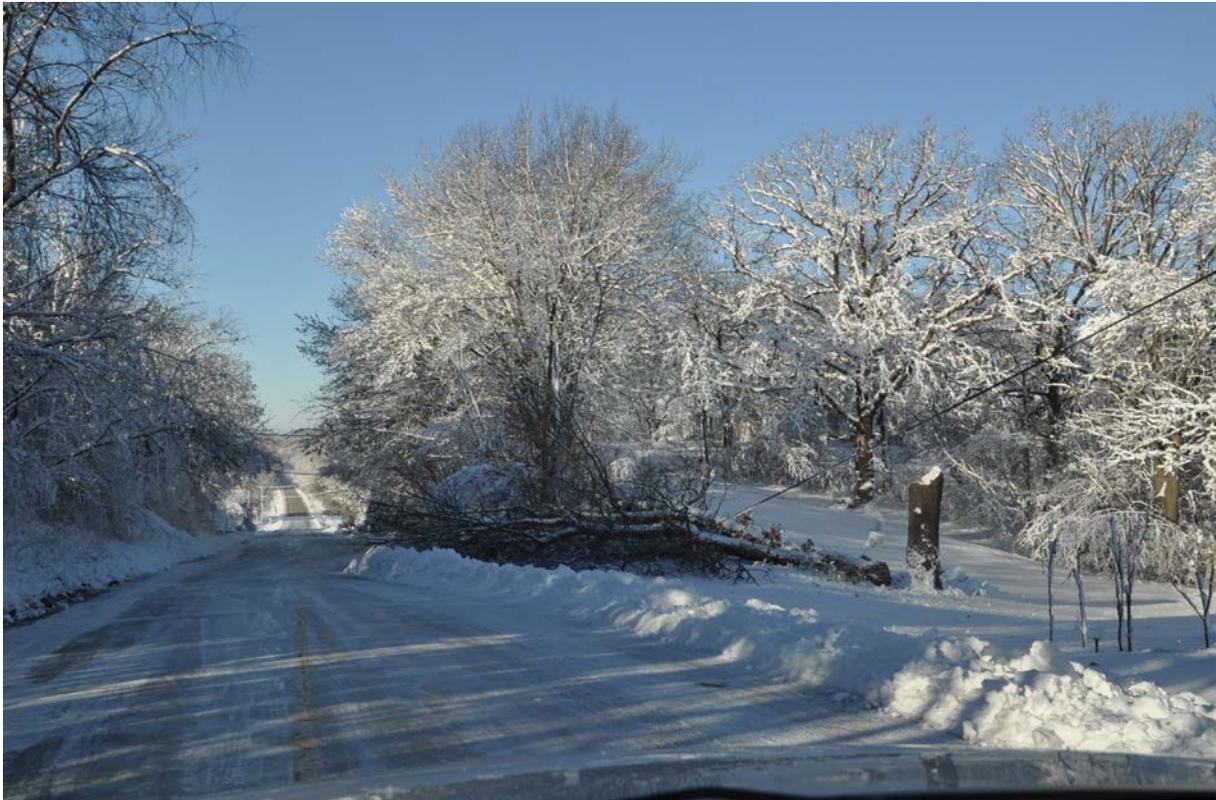
Figure 5: Fallen Tree and Downed Power Lines in West Des Moines after 12/19/12 Storm

Standard practice for winter storms in the City of West Des Moines is to use two 12 hour shifts until the levels of service have been obtained. This approach was used during the storm of 12/19/2012 and the twin shift approach was in place for four days at which time the roads were deemed to have been cleared to their level of service. Figure 5 shows a typical situation that crews had to address – a fallen tree that had taken down power lines, thus creating a potentially extremely dangerous situation.

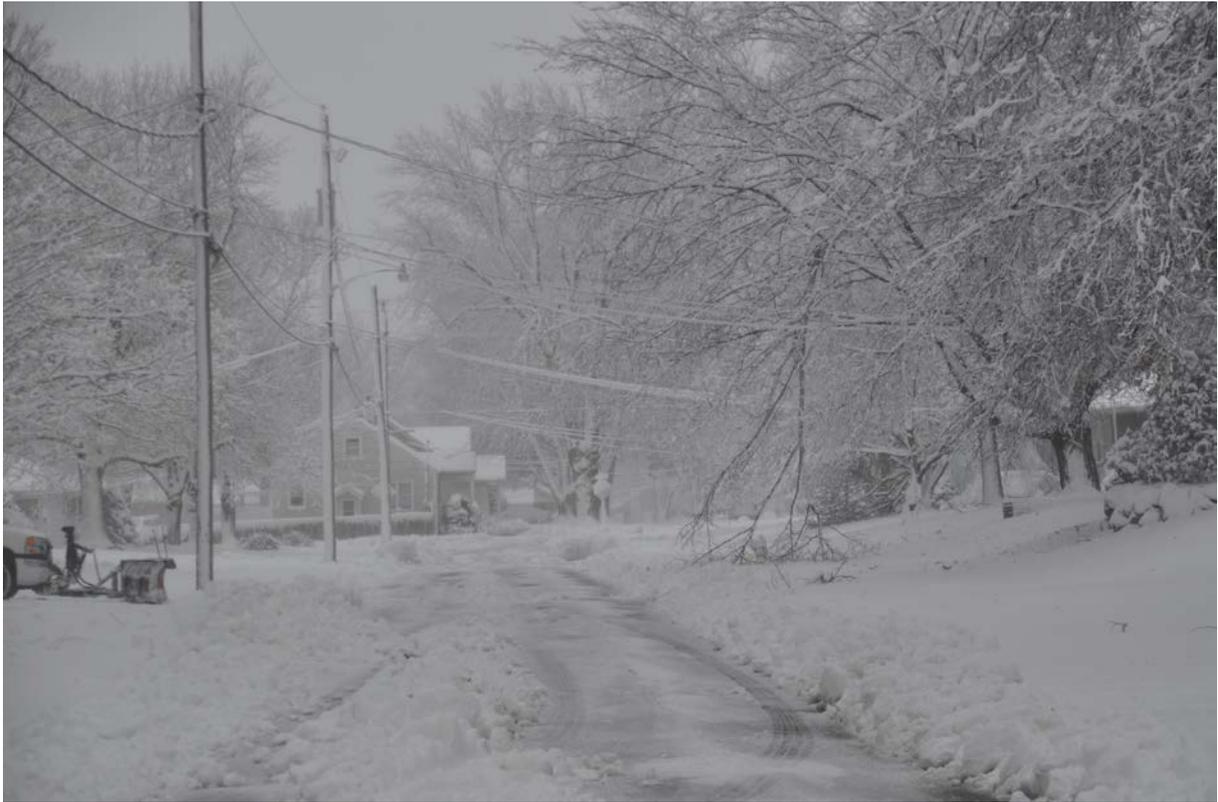
Figure 6: Frozen Road Surface Resulting from Wet Snow and Low Temperatures

The moisture in the snow and the rapidly dropping pavement temperature resulted in road surfaces that were heavily frozen, as illustrated in Figure 6. There were also issues with signs being covered in frozen snow, and with traffic lights (that used LED lights rather than incandescent bulbs, thus producing less waste heat) becoming invisible due to blowing and frozen snow, as illustrated in Figure 7. This was an added burden on an already taxed public works department.

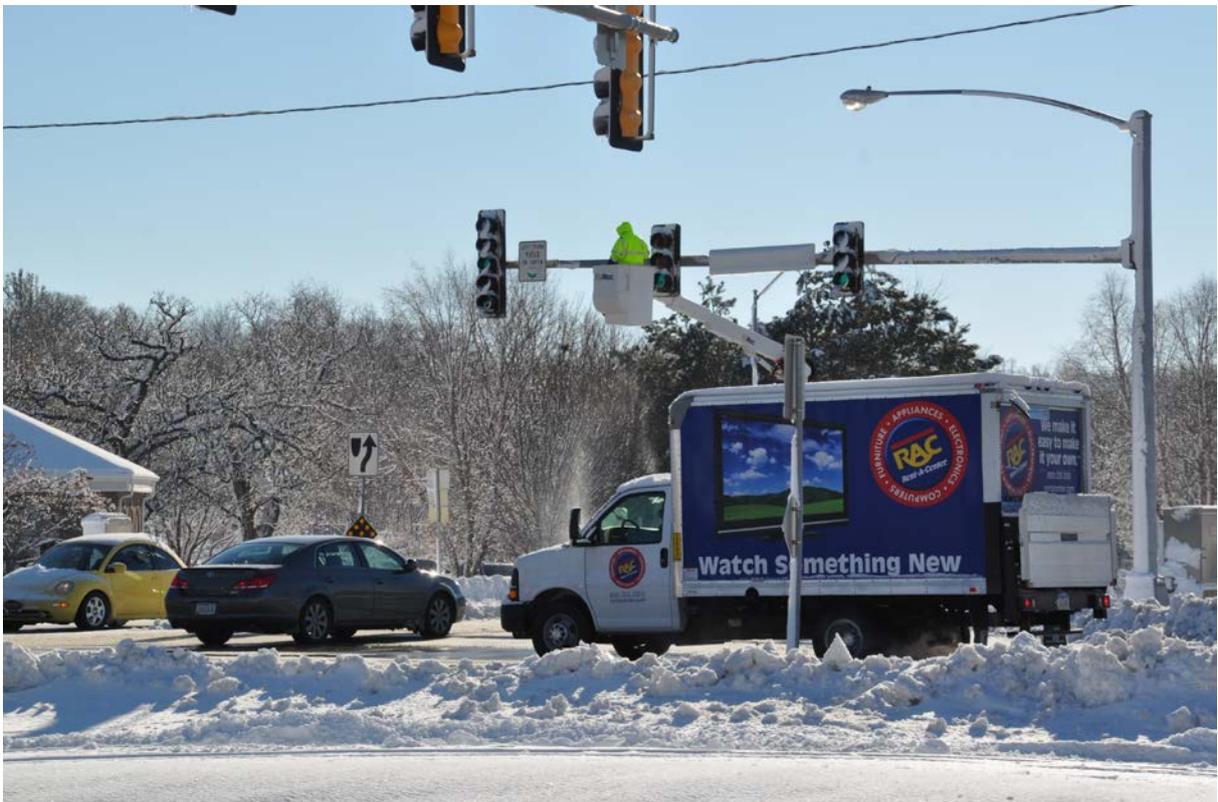
Figure 7: Snow Covered Traffic Lights Being Cleared of Snow
