Monitoring slipperiness on walkways

M. Hippi

Finnish Meteorological Institute
Meteorological Applications
P.O.Box 503, FI-00101 Helsinki, Finland

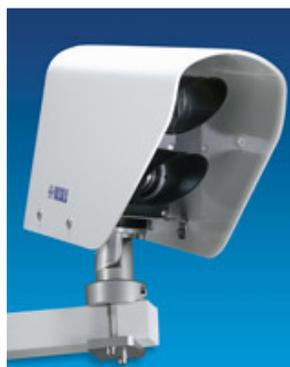
Vaisala has developed an optical sensor, DSC111, to measure the thickness of water/snow/ice on the surface [8] (see fig. 1). In case of snow or ice on the surface the instrument is measuring the water amount, to be precise. The device makes an estimation of the road surface classification and prevailing friction, too. Those sensors have been used to monitor the slipperiness on roadways and around 150 DSC111 sensors are installed around the Finnish road network. DSC111 sensor is installed usually at the same place where an ordinary road weather sensor is located on the surface, typically Vaisala DRS511 Road Sensor, measuring e.g. road surface temperature and other parameters, like the electrical conductivity giving information of the amount of de-icing chemicals on the surface [9].

Figure 1. Vaisala DSC111 instrument.

Vaisala has developed a DSC111 sensor to monitor the road condition and friction on the roadways, but there are no obstacles to use the sensor on the walkways as well. There are no previous results available about studies where the DSC111 sensor has been used to monitor the condition of walkways so this study is a kind of pioneering work on its field.

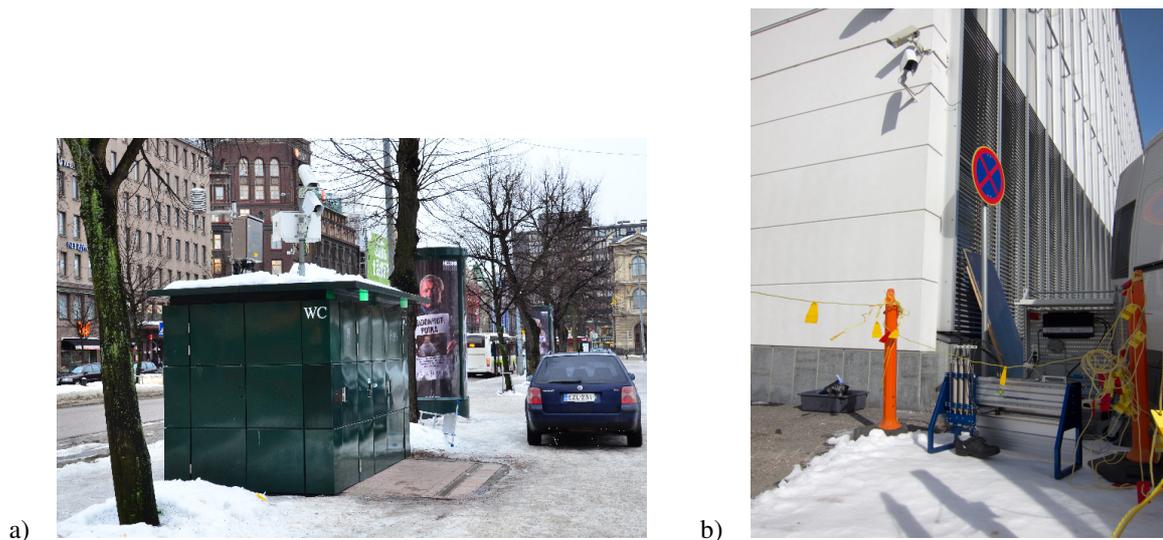
FMI has tested Vaisala DSC111 sensors to monitor the slipperiness on the walkways during last two winters. The sensors are located on Helsinki metropolitan area; one of them is installed on the corner of FMI's office on Kumpula and the other one is located on the city center near the Helsinki main railway station (see fig. 2). A web camera is attached next to the DSC111 device at the city center so the real situation on the pavement can be checked and compared from the photo as well. The sensors and camera have been in operational use since February 2011.

Figure 2. Vaisala DSC111 instruments installed on the vicinity of Helsinki railway station (a) and on the corner of FMI's office on Kumpula (b).

The software of DSC111 can eliminate moving obstacles, so cars and pedestrians passing by don't cause errors to the observed data. But static obstacles (e.g. parked cars) cannot be eliminated from the observations so those can cause errors every now and then. The devices are measuring every ten minutes and the data is stored to FMI's database. Also, there is a visualization page on FMI's intranet where the observations can be seen on real-time or later on.

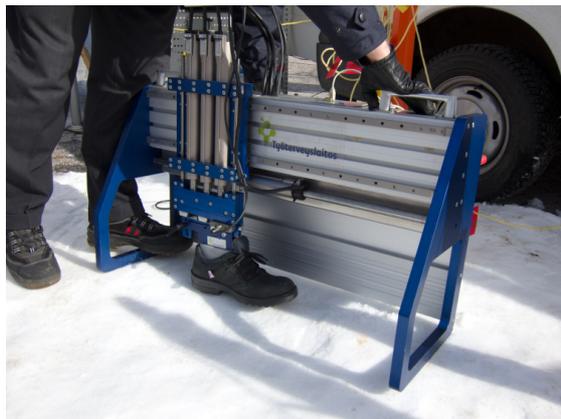
The Finnish Institute of Occupational Health (FIOH) has developed its own slipping detector [10]. It is a mechanical in situ simulator measuring the slip resistance. A shoe can be attached to measure the grip between surface and sole (see figure 3). As a result the simulator gives an estimation of the coefficient of friction between the surface and the shoe sole. Different shoe types with different material and pattern of shoe sole can be tested by the simulator. The results of the FIOH's slipping simulator have been used when developing the FMI's

Figure 3. A slip resistance simulator developed by Finnish Institute of Occupational Health.

The experiences of the slipmeter measurements are good, results are reliable and the information between different shoe soles is useful. This device is good and results are reliable but the device can be used for case study purposes and separate measurement campaigns. But the device needs always somebody to use the device so the operational use is impossible

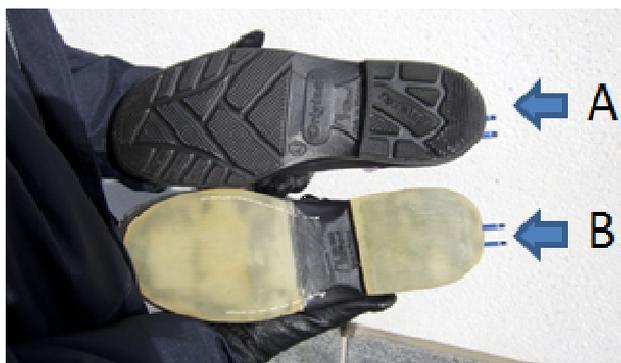
Two different kind of shoes were tested with the slipmeter (see figure 4); the first one (A) was a shoe sole with a good grip and the other (B) was as very slippery shoe – like a curling shoe. The results of the slipmeter measurements are presented on table 1. The simulations were repeated five times. There were some variations between the measurement result and the differences were mainly caused by the rough surface.

Figure 4. Shoe soles used in the slipmeter simulations; shoe A with a good grip sole and shoe B with a slippery sole.
