## Observing the variability of road and weather conditions with hybrid mobile and fixed sensors

Project ColdSpots was studying problematic road stretches in Finland having more than average accidents due to road conditions. In January-February 2007, the project conducted an intensive observing campaign. Few main roads in Southern Finland were measured with a mobile unit to find out the local variability of weather parameters and in particular friction. Fixed and mobile observations were combined, and their ability to reveal the local variability analysed. Further development of hybrid road weather observing systems is encouraged.

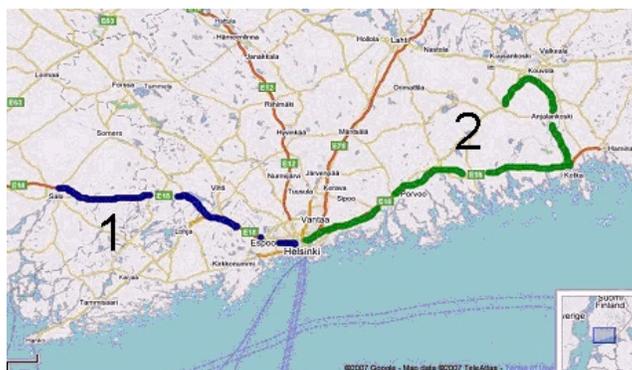
Fig. 1 Main ColdSpots measuring routes in Southern Finland

The main observing route was from Helsinki to Salo and back, along Main road 1, which is known for its difficult and rapidly changing road conditions. It is also equipped with exceptionally dense network of road weather stations. Another route was to the east of Helsinki along Main roads 6 and 7 and some local countryside roads. Routes are shown in Fig.1 as blue (1) and green (2), respectively.

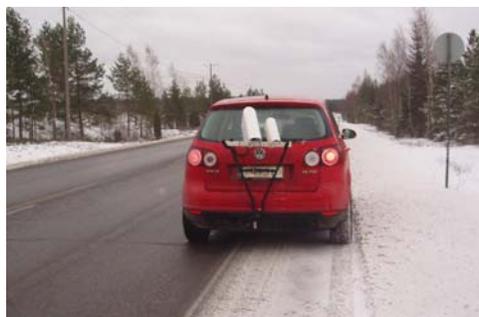
Fig. 2 DSC111 and DST111 installed for mobile measurements

The mobile measuring unit was installed at the back of VW Golf. The optical sensors DSC111 and DST111 by Vaisala Inc [5], [6] were tilted somewhat to measure the area behind the right wheel path. The measuring area was thus approximately a palm-sized oval few meters behind the car. DSC111 is measuring the amount of ice, snow and water on the road surface and calculating friction from the observed values. DST111 measures road and air temperature and moisture. Continuously measured values are averaged every six seconds, corresponding to about 130 meters distance with normal 80 km/h speed. Data from sensors was transmitted to a measurement PC via Bluetooth connection. The PC had a separate GPS receiver to collect the exact position of the car.

It was observed that the exhaust fumes and the car itself made a consistent warming effect of 2-4 degrees to the DST111 air temperature measurements, and thus those were not used in the analysis. Observations of road weather stations along the routes were collected, as well as the temperature sensor measurements of the VW car.

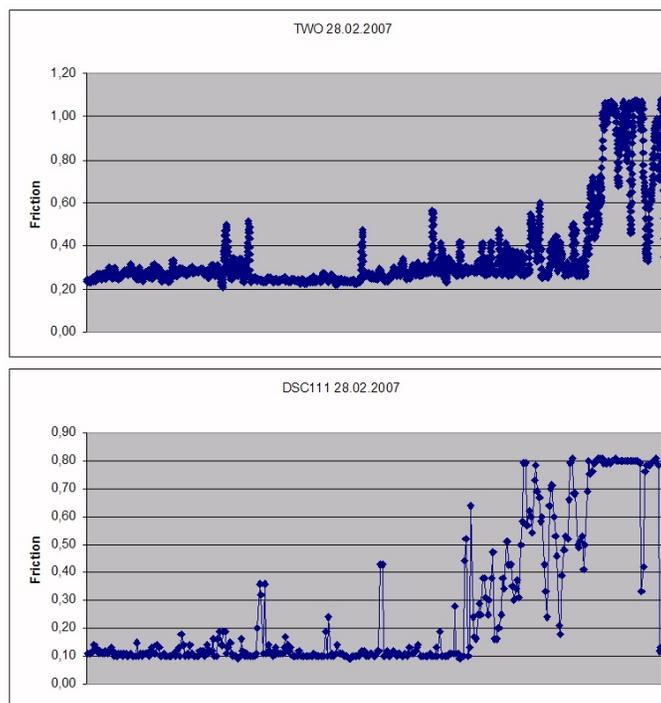
Fig. 3 Comparison of friction measurements with optical DSC111 and TWO friction wheel

The early winter in 2007 was the warmest ever observed in Finland, and spring started very early. Nevertheless, 11 interesting cases were measured in January-February. The last measurement included also a comparison study using the Norwegian TWO friction wheel. Fig.3 shows one example of a route, which started on snow-covered small road and ended up to a well-maintained main road. One can see that the observations are by and large quite similar, but the measured values vary between 0.2-1.1 and 0.1-0.8 for TWO and DSC111, respectively.

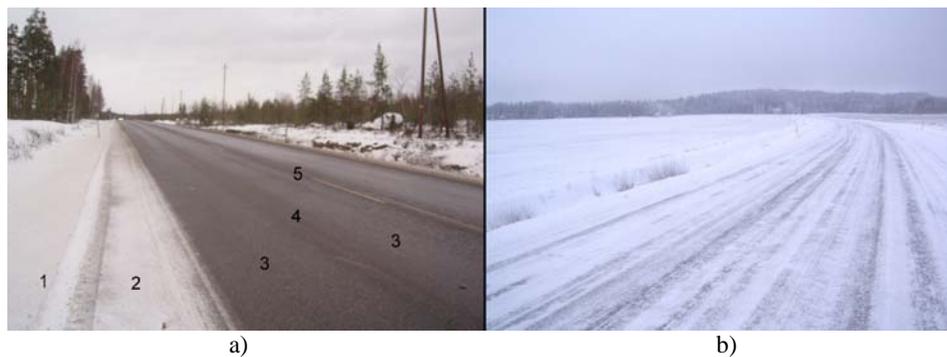
Fig. 4 Friction varies differently across the roads depending on the road type.

- a) Main road with 1 snow walls, 2 road sides, 3 wheel paths, 4 between wheel paths, 5 between lanes.
- b) Local road with lower level of service, covered with compacted snow or ice. Friction is generally low all over across the road.

Generally speaking, it is well known that friction varies considerably across the road as is depicted in Fig. 4. A typical wintertime main road is shown on the left, and it can have friction variance easily from 0.2 to 0.8, if friction is measured on roadside, wheel path or between lanes. To complicate the scene even further, during snow fall or accumulating hoar frost the effects caused by traffic can be opposite, i.e. friction may be better or worse along the wheel paths. On a local road covered with compacted snow or ice situation is more simple, as friction is usually quite low all along the road. However, with DSC111 friction may be sometimes underestimated with packed snow, or overestimated if packed snow has been covered by a thin layer of water.

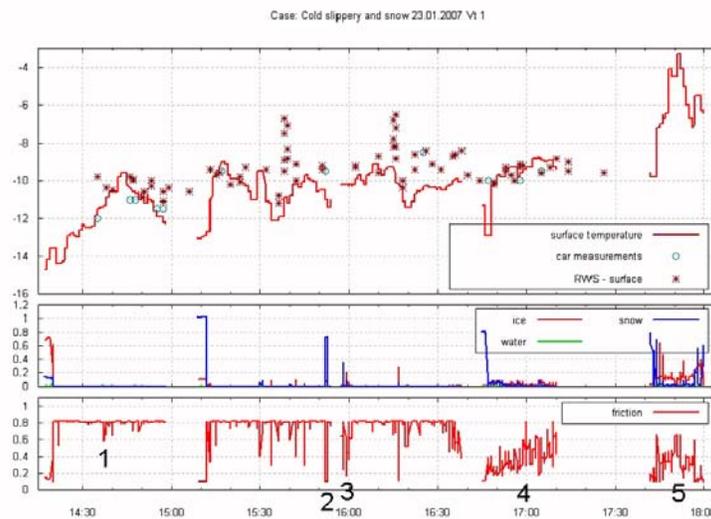
Fig. 5 Case 23012007 starts with cold but fair weather turning into snowfall.

The first case of Fig. 5 was a cold, fair day, which turned into snowfall. Temperature measurements from DST111 (red curve), road weather stations (crosses) and the car (circles) are shown in the upper box. Middle box shows values of ice, snow and water (in mm) observed by DSC111, and the lower box the calculated friction value. Point 1 shows one ColdSpot, when a small bridge was crossed with immediate observation of lower friction. In point 2 the car has been stopped by the roadside, which was snow-covered. There was already weak snowfall, and the passing lanes were covered with a thin snow layer. This is shown well in point 3, where the car was driving along a passing lane. Friction dropped to 0.2-0.3, indicating very slippery road surface. In point 4, snowfall was getting heavier, causing lower friction. Section 5 on the right shows how the streets of Helsinki look like in these measurements, as they are regularly covered with plenty of snow and ice. City maintenance is very low quality compared to main roads.

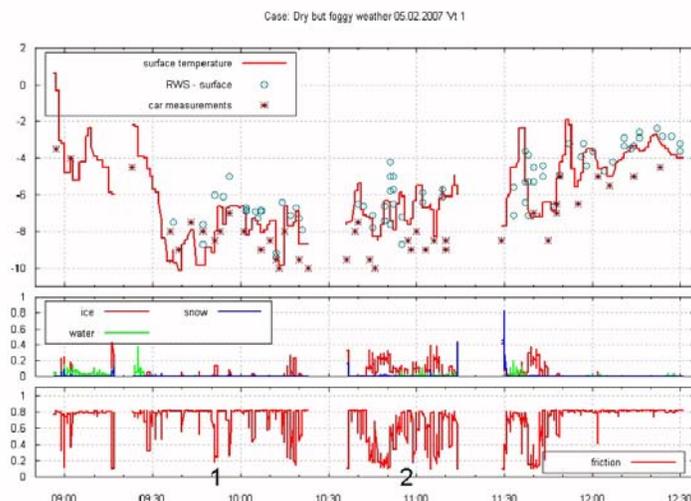
Fig. 6 Case 05022007, fair but foggy, hoar frost

Second case in Fig. 6 was driven with a winter maintenance expert in the car. All temperature sensors recorded similar values between  $-6\dots-10$  degrees. Point 1 is a ColdSpot, a hillside that is known to get slippery very easily. Also in this case it was noticed that hillside was thinly covered with ice and friction was low. Salting unit was called to maintain the spot. Section two shows the period when air was very foggy at times along the road. Water due to salting and ice due to frost formation was observed on the surface, causing strongly varying values of friction. Good friction values on the right are from well-maintained highway.

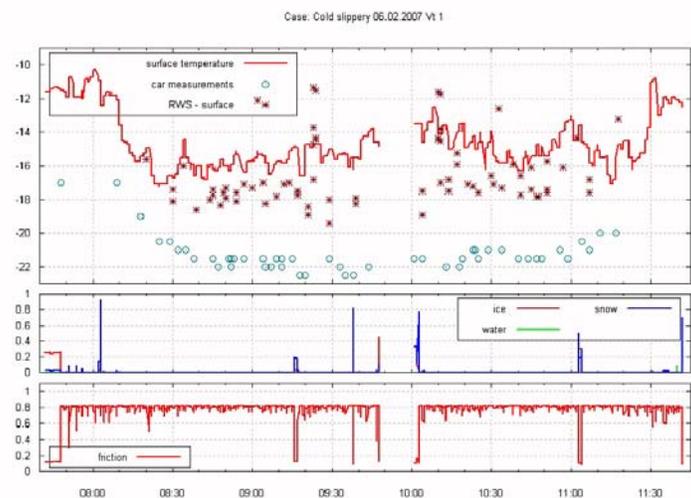
Fig. 7 Very cold case with good friction

The first case is very cold and dry, and the measured friction was very good along most of the route. Only stops at the roadside or driving along the passing lane showed smaller values. Temperature measured by the car sensor was lowest, around  $-22$  degrees, which corresponds to true air temperature rather than road surface temperature. The RWS road surface was some 4-6 degrees warmer. Values measured with DST111 were the warmest, indicating the effect of road body temperature. The previous day had been very warm with the road temperatures around  $-2$  degrees, and thus the road body was still considerably warm.

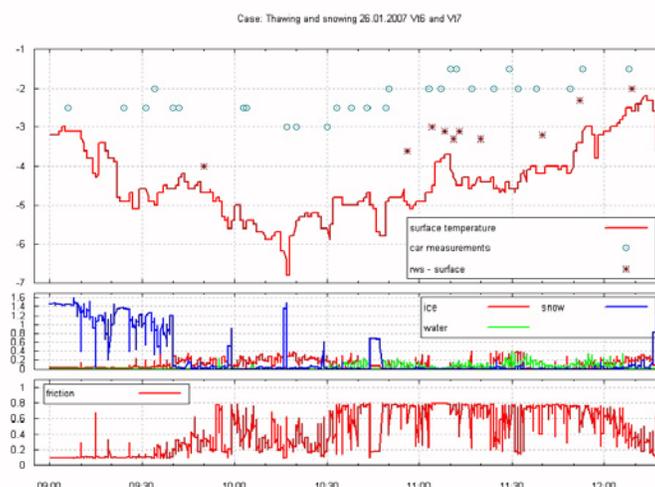
Fig. 8 Case with thawing and heavy snowfall

The final case in Fig. 8 is the one with heavy snowfall and temperature steadily rising. Again there is systematic difference between the three temperature measurements, but now DST111 shows the coldest values. This is logical as the road body temperature was low due to the previous night with temperatures around  $-10$  degrees.

Very low friction values on the left are measured along a local snow packed road. Effects of accumulated snow and water to friction can be seen on the right. Driving conditions were very poor also due to bad visibility.
